## Memorandum

Date: 14 June 2006  
To: Mark Anderson / Gary Morin  
From: Don Boyé  
Subject: Results of Building Materials Sampling – Aerovox Building – May 2006

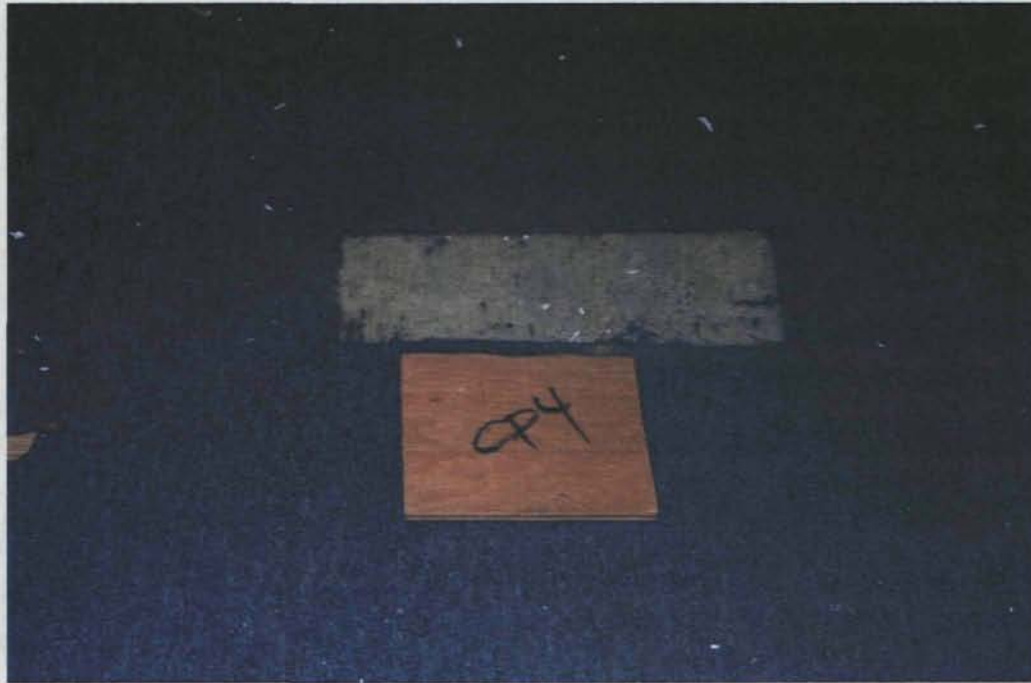
- The most significant PCB contamination, ranging from 125 to 774 mg/kg, was found in the carpet samples. The highest values were found along a likely traffic pattern between the adjoining Aerovox administration areas and the front entrance of the building.

**Figure 3 – Typical Carpet Sampl**

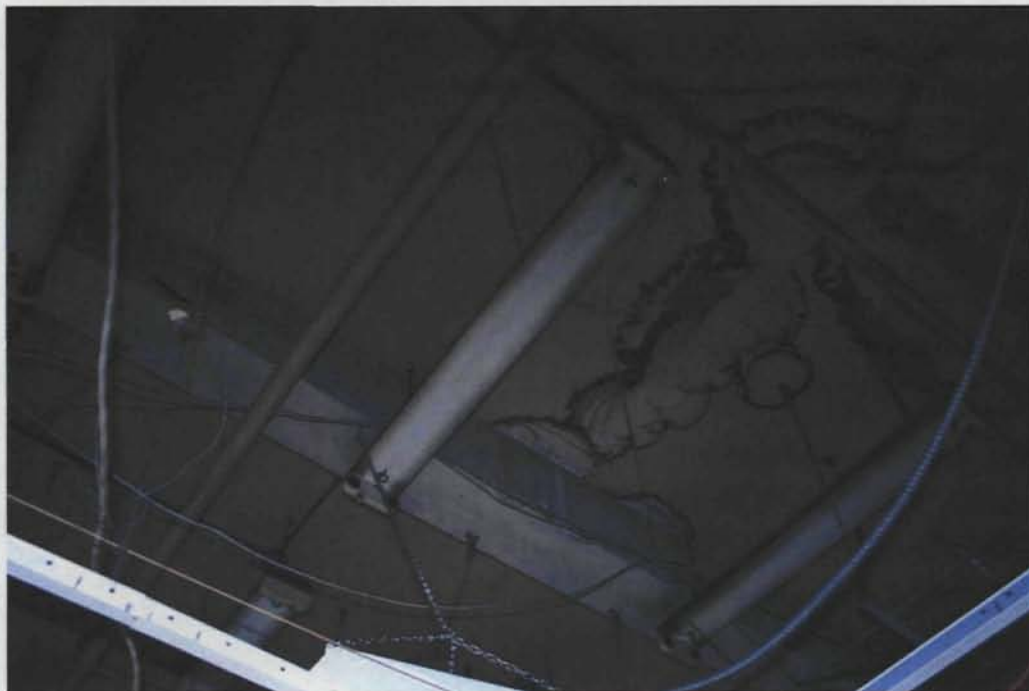
- Samples collected from ceiling panels (material properties similar to sheets of particle board) ranged from 27 to 45 mg/kg (5 samples). These ceiling panels showed signs of discoloration from water intrusion through the roof membrane in many locations and sampling typically targeted these areas wherever possible. These ceiling panel samples had the highest PCB contamination for any of the sampling conducted above the finished drop ceiling of the annex.

**Figure 6 – Overhead Ceiling Panels**

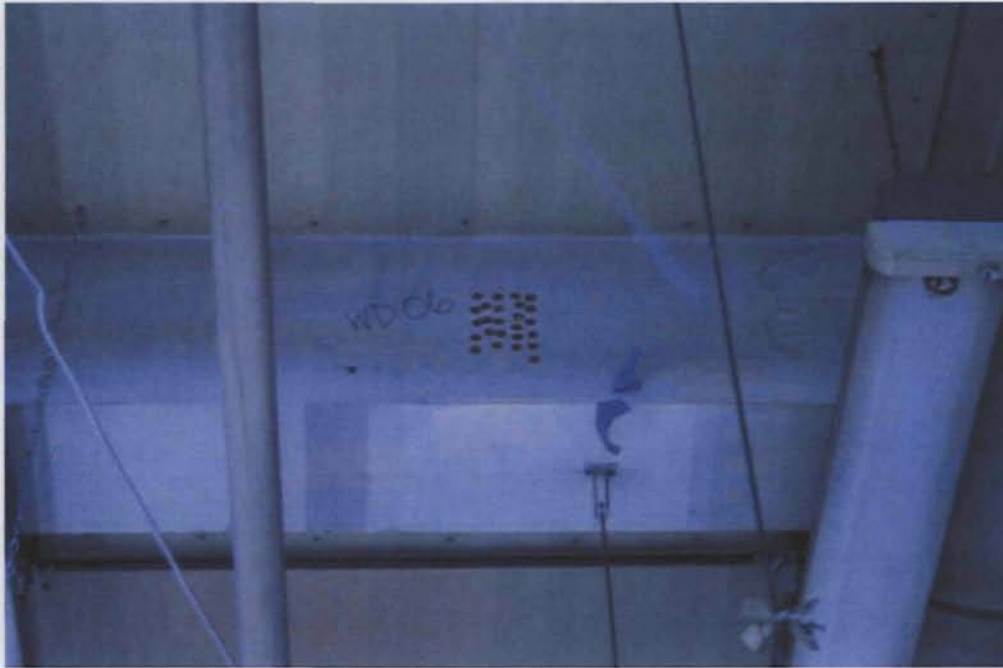
- Samples of structural wood timbers (painted surface) typically ranged from 4 to 11 mg/kg (8 of 10 samples); the remaining two samples were less than 4 mg/kg.

**Figure 7 – Typical Wood Beam Sample**

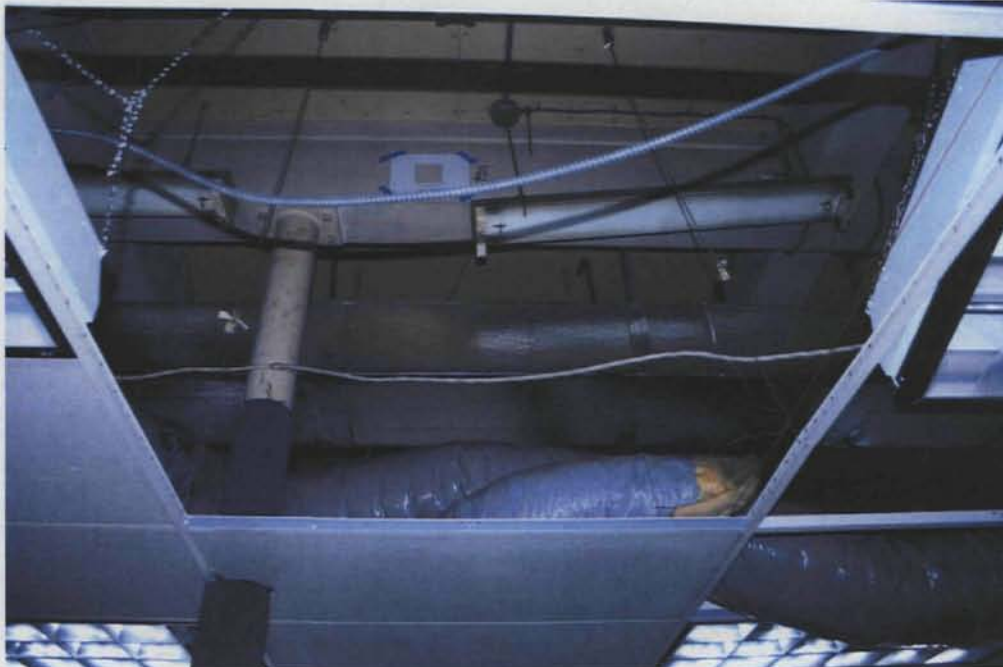
- Wipe samples were collected from two elements above the finished drop ceiling, including the main structural I-beam running the length of the annex, and from interior surfaces of ventilation ductwork. The results for these samples ranged from 0.31 to 1.2 ug/100cm<sup>2</sup> (steel) and 0.8 to 5.5 ug/100cm<sup>2</sup> (vents). The interior surfaces of the ventilation ductwork generally held accumulated deposits of black particulate matter.

**Figure 8 – Wipe Sample Site - Steel I-Beam**

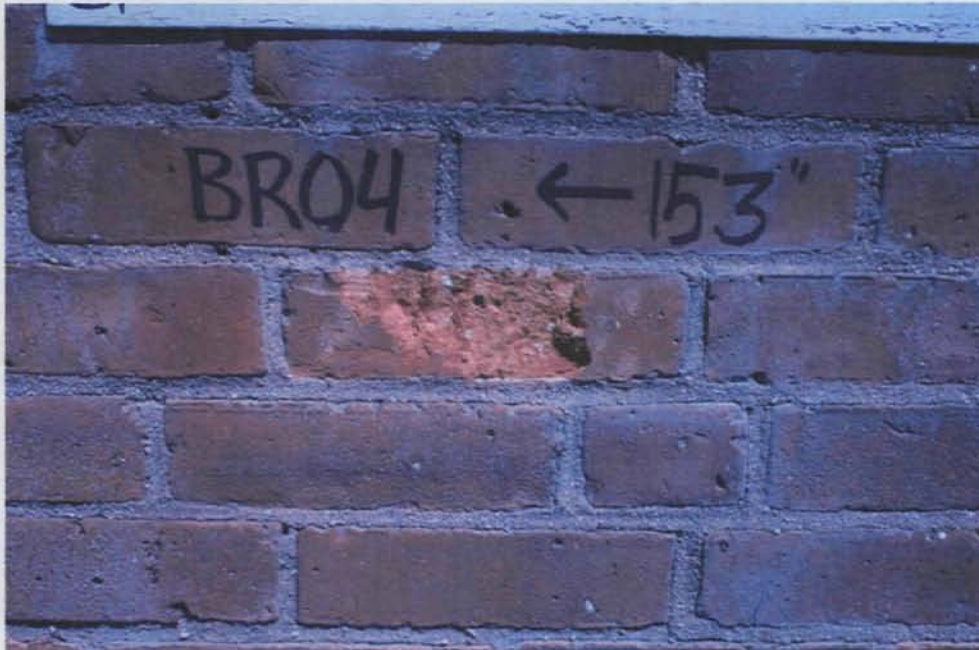
- Wipe samples from the flag pole and solid samples of the brick facade were all non-detect.

**Figure 9 – Typical Brick Sample**

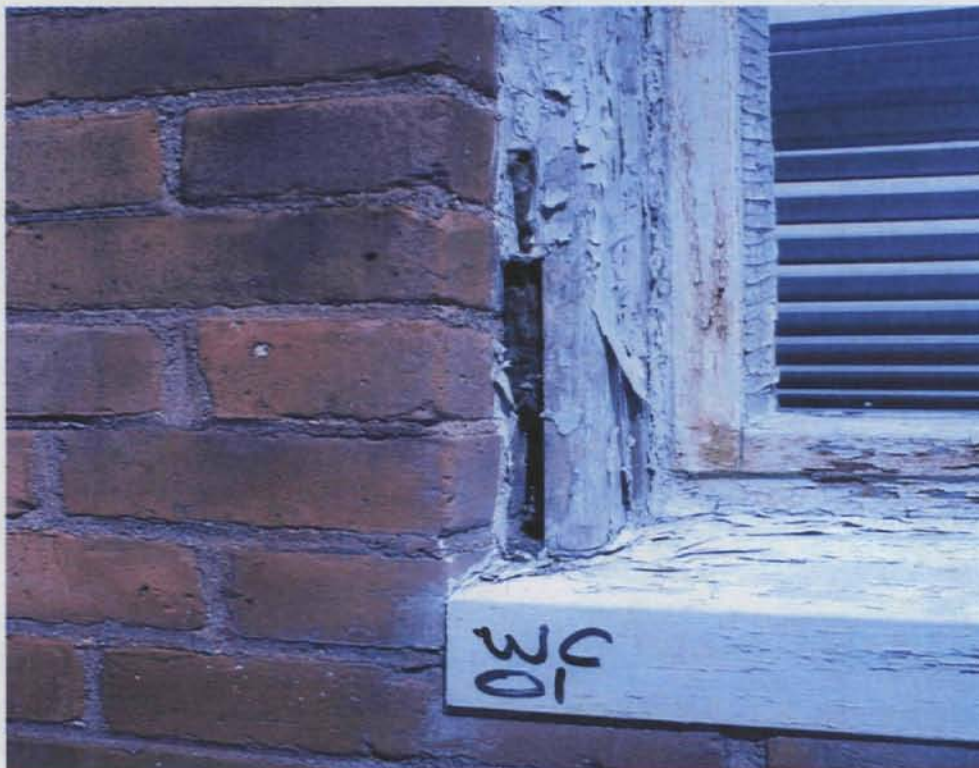
- Samples of window caulking ranged from 18 to 36 mg/kg. These values are more likely an artifact of the natural properties associated with the caulking formulation of the era as opposed to

“after-market” PCB contamination (PCB Site Revitalization Guidance under the Toxic Substances Control Act – TSCA, USEPA 2005).

**Figure 10 – Typical Window Caulking Sample**
